**North Bank Playground****Completed By: Patrick McCord****Date of Report: March 03, 2020****Time of Observation: 1:00 PM**

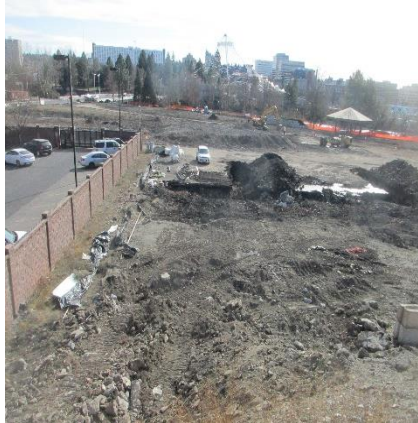
#1 View from cliff east side of the cliff (facing south)

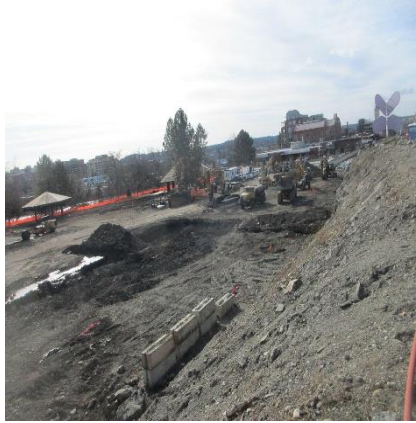
#2 View from east side of the cliff (facing west)

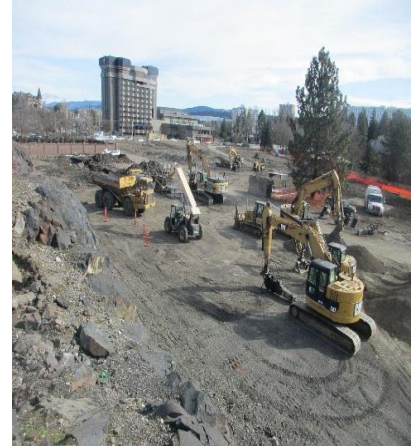
#3 View from west side of the cliff (facing east)

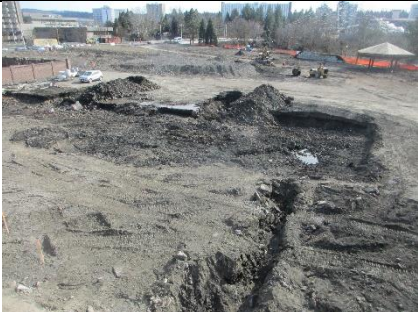
#4 Area of petroleum soils removal.

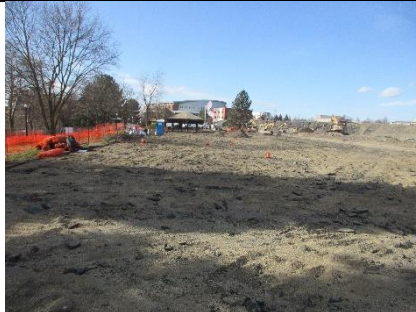
#5 View from southeast corner (facing west)..

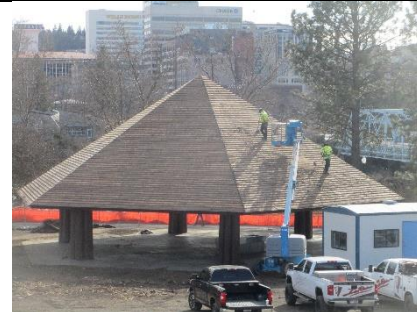
#6 Large shelter.

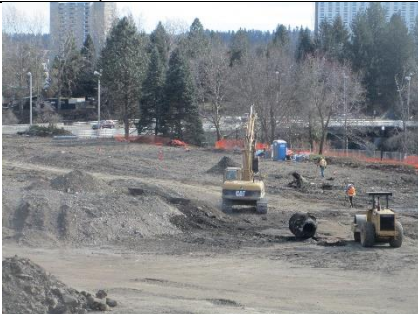
7 Existing parking lot.

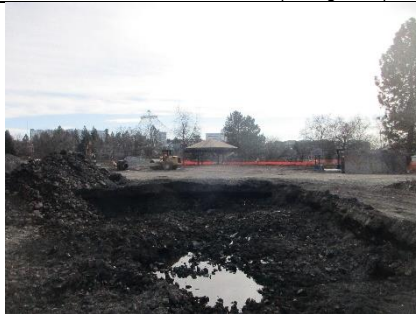
#8 Standing water in the petroleum area..

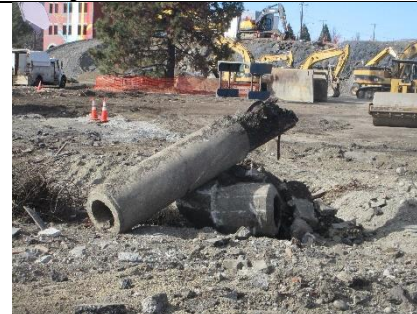
#9 Demolished stormwater inlets.
